Channel Mitigation Monitoring Sheets I, II, III, AND IV

Monitoring Data Record

Project Title: B-4191 (Br. No. 82 over Jacktown Creek on NC 226)
COE Action ID: SAW-2009-0707 DWQ Number: 20090385
Stream Name: Jacktown Creek
City, County and other Location Information: McDowell County, Bridge #82 over Jacktown Creek on NC Highway 226, approx. 0.2 miles south of I-40 adjacent to McDowell Technical Community College.
Date Construction Completed: 3/29/12 Monitoring Year: (4) of 5
Ecoregion: Eastern Blue Ridge Foothills 8 digit HUC unit 03050101
USGS Quad Name and Coordinates: Marion West 35.655352, -81.959133

Year 4 Winter – March 2015

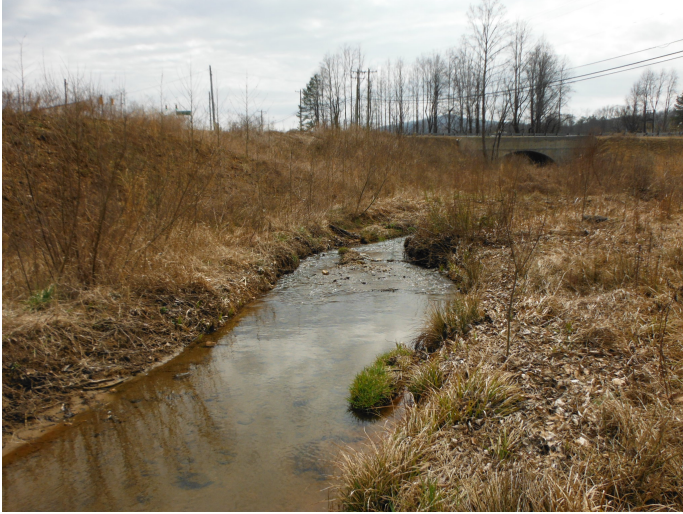
The Jacktown Creek stream restoration site is stable for the Year 4 Winter evaluation, except for left bank erosion at Sta. 12+50. A mid-channel bar was also observed at Sta. 11+00 but this area remains stable at this time. See the bankfull dates throughout the monitoring period below and how the bankfull events were noted. This site has met the bankfull requirement of two bankfull events must occur over the five year monitoring period. NCDOT will continue to monitor channel stability at the Jacktown Creek stream restoration site and look into remedial action possibilities to stabilize the left bank at Sta. 12+50.

Sta. 11+00 (mid-channel bar)

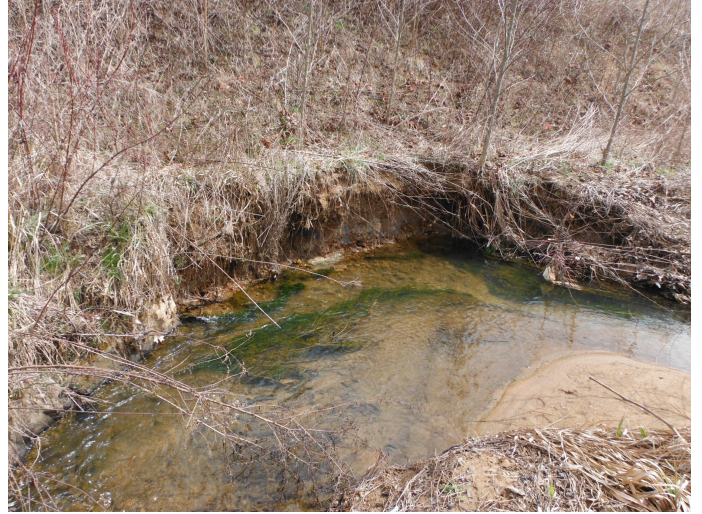
Sta. 12+50 (left bank erosion)
